**DEPARTMENT OF TRANSPORTATION**

Quality Assurance and Source Inspection

Caltrans Quality Assurance (QA) Inspector, Mike Hasler was present to observe the fitup, welding and related activities associated with the fabricating of Caltrans Mock-up, 77M, 89M, 114M, Orthotropic Box Girders (OBG) and Tower, for the San Francisco Oakland Bay Self Anchored Suspension Bridge, at Zhenhua Port Machinery Company (ZPMC) facility on Changxing Island.

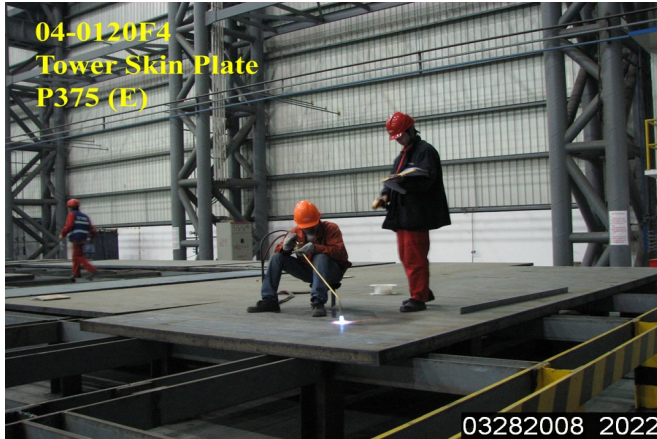
New Tower Shop: The Caltrans QA Inspector observed ZPMC performing flame heat straightening operations on tower skin plates for mill distortion. The tower skin plates and heat straightening procedure are identified as skin plate P375 (E), procedure HSR1 (T) 344, revision (0) and skin plate P456 (E), procedure HSR1 (T)-261, revision 0. ZPMC was observed heating the plate manually with a rose-bud torch. Caltrans QA observed ZPMC Quality Control Inspector, Mr. Xu Jin Long monitoring the heat straightening of the plate using a calibrated infra-red temperature indicating device to monitor the heat. The following digital picture illustrates heat straightening in progress.
